City of Missouri City Park Facilities Assessment Management Plan

2018

M2L Associates, Inc.

Park Restroom Building Assessment - Executive Summary

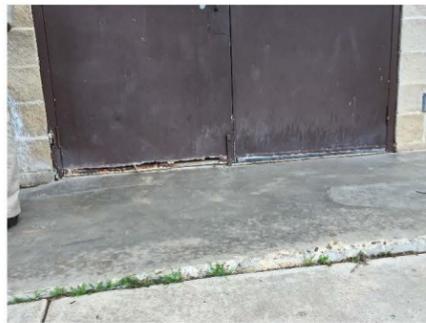
It was observed at multiple locations, particularly of the "Walcon" type buildings, that subsidence on the soils around the perimeter of the building have damaged and left exposed the steel imbeds of the concrete panels. The subsidence has also created edge conditions at the slab/sidewalk that violate the maximum height of a building threshold for wheelchair access to the restrooms. Based on the observed conditions, the following remediations are recommended.

Typical unlevel slab/sidewalk

- A. At perimeter of concrete wall buildings, stabilize existing footings with new helical piles; existing adjacent site paving should be raised to the edge of building slab by method of mud-jack or polyurethane foam injection; damage to existing steel imbeds should be treated for rust condition, caulked and sealed.
- B. If foundation stabilization is not provided, concrete sidewalks should still be leveled to the finish floor of the building slab and steel imbeds of the concrete walls repaired and protected.

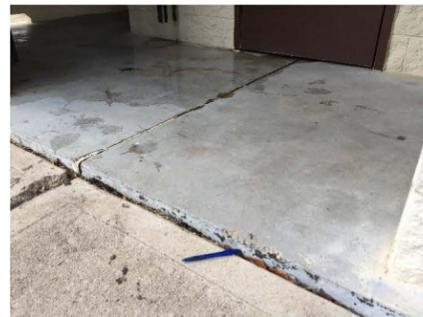
Ponding water at slab

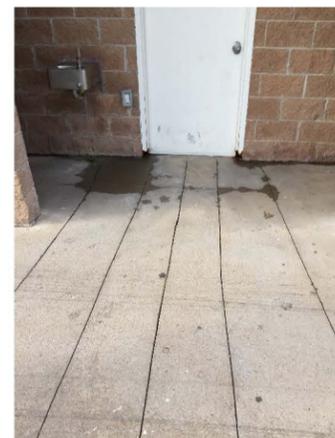
Attempts to remedy water ponding

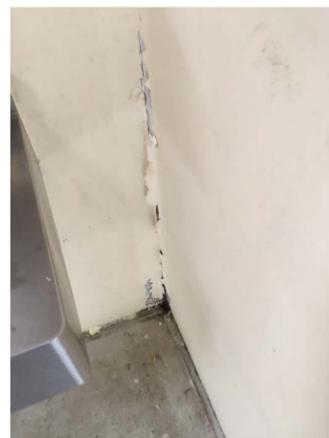
Concrete panel damage

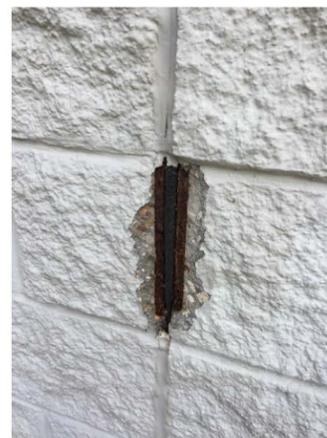
Exposed steel imbed

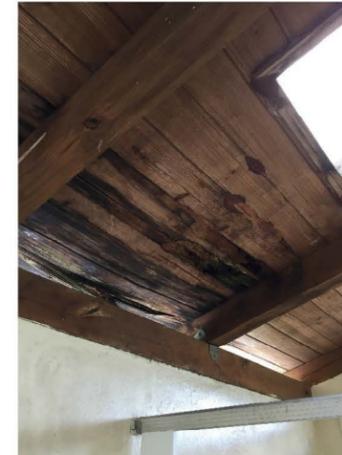
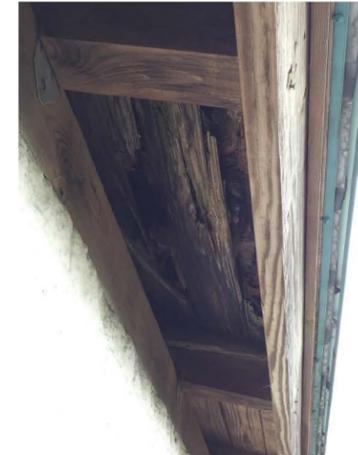
It was observed that the skylight has been a point of water infiltration at the roof of multiple restroom buildings. Water infiltration appears to be occurring where the bottom of the skylight flashing meets the standing seam metal roof. This condition, aided by the absence of a roof deck membrane such as roof felt or ice & water shield, has allowed the cumulative infiltration events to degrade the wood roof deck to the point of failure. Based on the observed conditions, the following remediations are recommended:

Interior and Exterior wood deck damage typical at buildings with standing seam roofs and skylights

- A. If it is desired to keep the skylight, the standing seam metal roof should be removed & reinstalled to allow for the replacement of the existing wood deck and an added roof membrane such as 30# tar impregnated felt or ice and water shield. The flashing of the skylight should be removed and reinstalled once properly flashed and sealed.
- B. If the skylight can be removed from the roof, the standing seam metal roof and skylight should be removed and the existing wood deck replaced and installed at the skylight opening. An added roof membrane such as 30# tar impregnated felt or ice and water shield. Interior LED lights on a timer or sensor can be installed to account for the absence of natural light provided by the skylight.

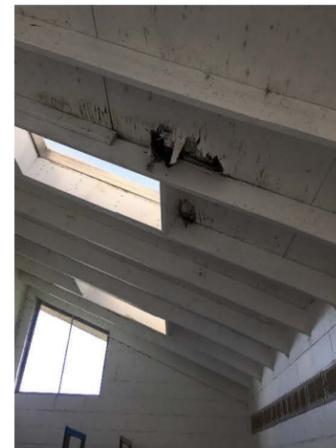
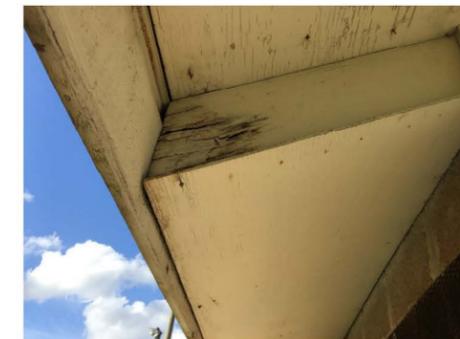
Damage to the roof deck and joists at Stamo Park from damaged skylights

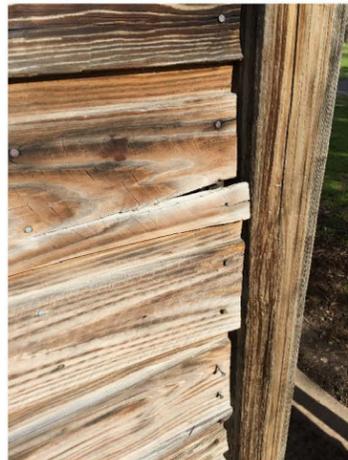
Wood Components: The wood building components are in variable states of degradation due to unprotected exposure to sun and rain. Semi-exposed wood, such as roof deck shows age and slight damage due to water and high humidity. Exposed wood components directly exposed to the sun and rain, such as siding and eaves show greater signs of damage to the point of needing to be removed and replaced. Based on the observed conditions, the following remediations are recommended:

Siding at Ridgeview

A protective membrane should be applied to all exposed wood members.

- A. Wood desired to be left looking "natural" should be sanded/prepped and have 2 coats of a protective penetrating oil or sealer applied to the exposed surfaces.
- B. Wood previously painted, or that can be painted, should be sanded/prepped, primed and finished with 2 coats of exterior grade paint.

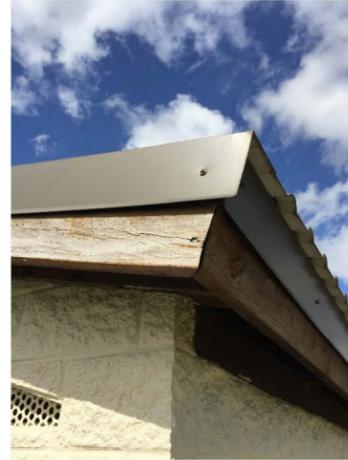
Typical unprotected eaves

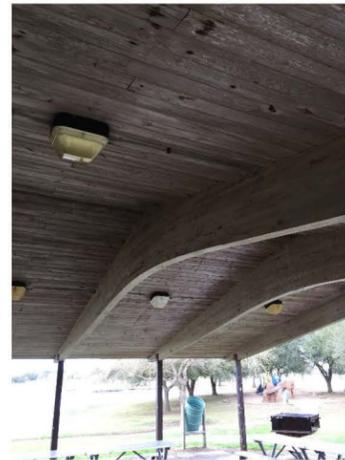
Exposed roof deck

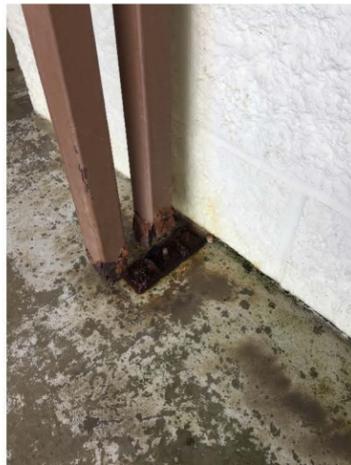
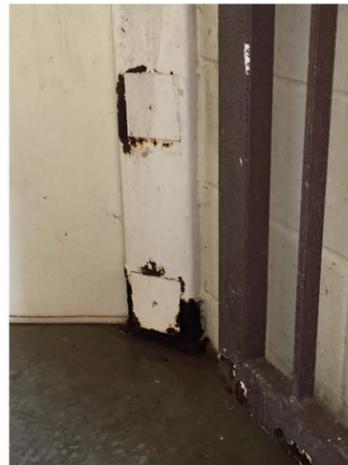
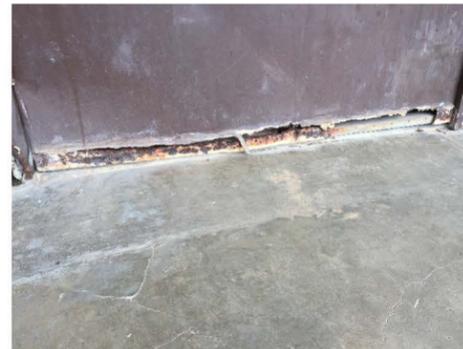
Metal/Steel Components: Exposed metal or steel building components that have endured prolonged contact with water show severe degradation. Some others described in the individual report describe components that may need to be replaced in their entirety. For components that can be repaired the following remediations are recommended:

- A. For structural components of the building, such as the steel imbeds at the concrete panel or steel tube columns, the immediate area should be thoroughly dried and rust removed from the components with steel wool or mechanical means. The freshly exposed steel should then be primed and a suitable coating be applied to the substrate. Where appropriate, apply joint sealant to the components.
- B. For non-structural exposed steel components, such as the security gates, efforts should be made to relocate metal bearing directly on the concrete slab to the vertical wall surface, i.e. Roane Park.
