City of Missouri City Park Facilities Assessment Management Plan

2018

M2L Associates, Inc.

Park Restroom Building Assessment - Executive Summary

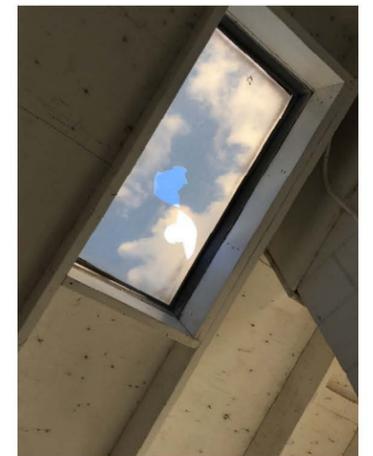
Damage to the roof deck and joists at Stamo Park from damaged skylights

Wood Components: The wood building components are in variable states of degradation due to unprotected exposure to sun and rain. Semi-exposed wood, such as roof deck shows age and slight damage due to water and high humidity. Exposed wood components directly exposed to the sun and rain, such as siding and eaves show greater signs of damage to the point of needing to be removed and replaced. Based on the observed conditions, the following remediations are recommended:
